OUTER SKIN PROTECTION OF COLUMBIUM THERMAL PROTECTION SYSTEM (TPS) PANELS

by
John D. Culp

MCDONNELL DOUGLAS ASTRONAUTICS COMPANY

Contract NAS3-15546

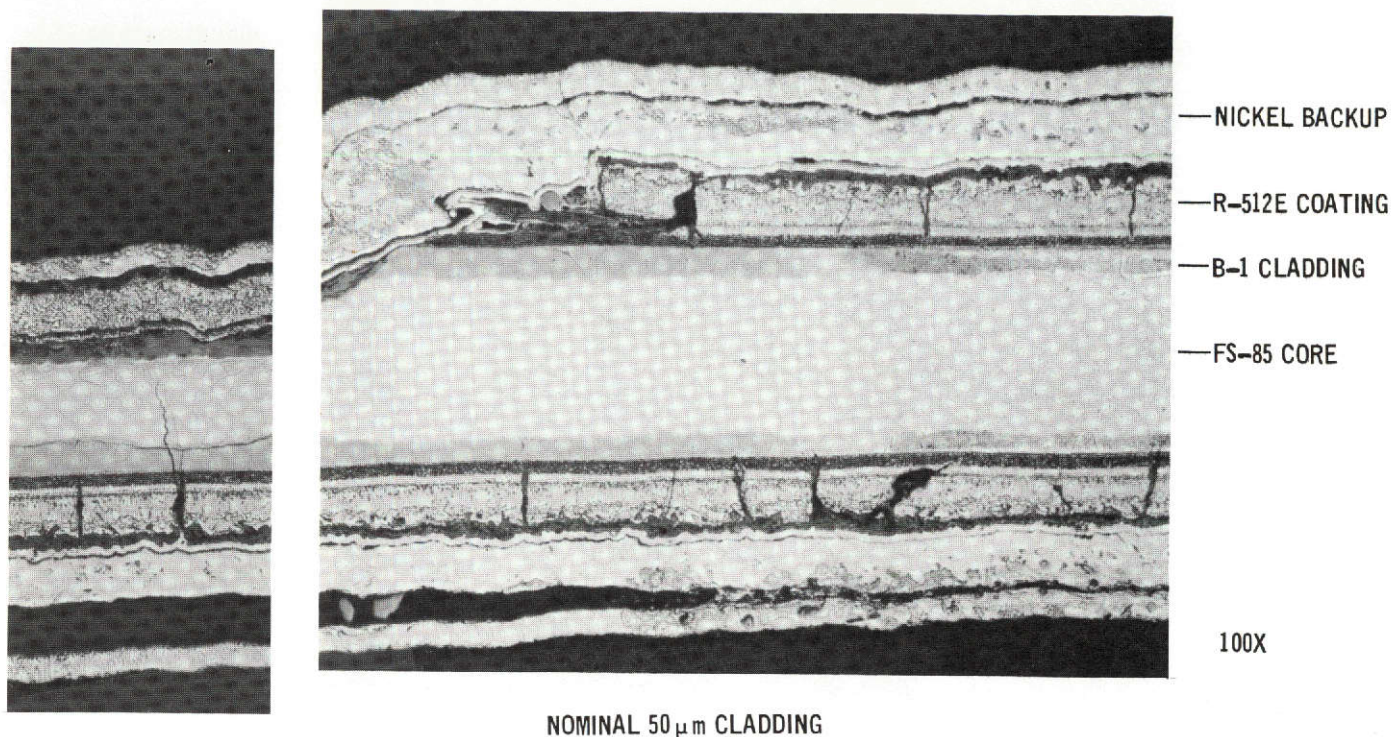
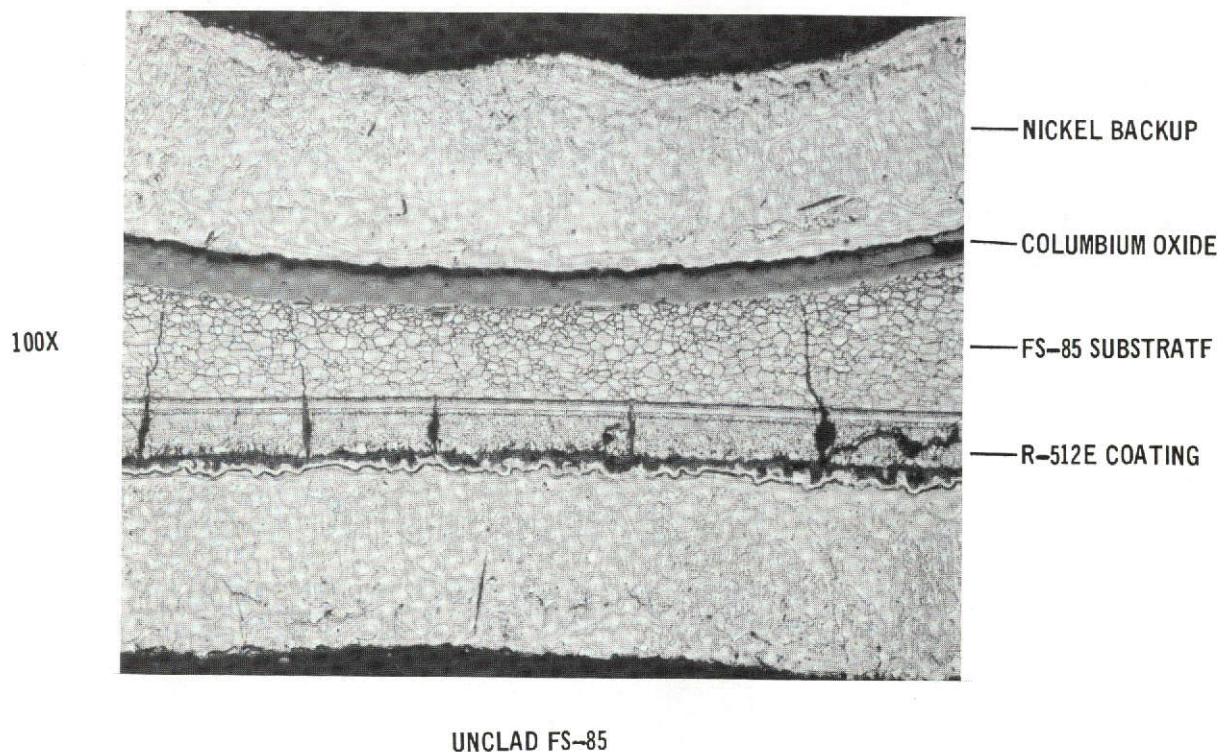
FIGURE 28 EFFECT OF 15 REENTRY EXPOSURE CYCLES ON B-1 CLAD
AND UNCLAD FS-85

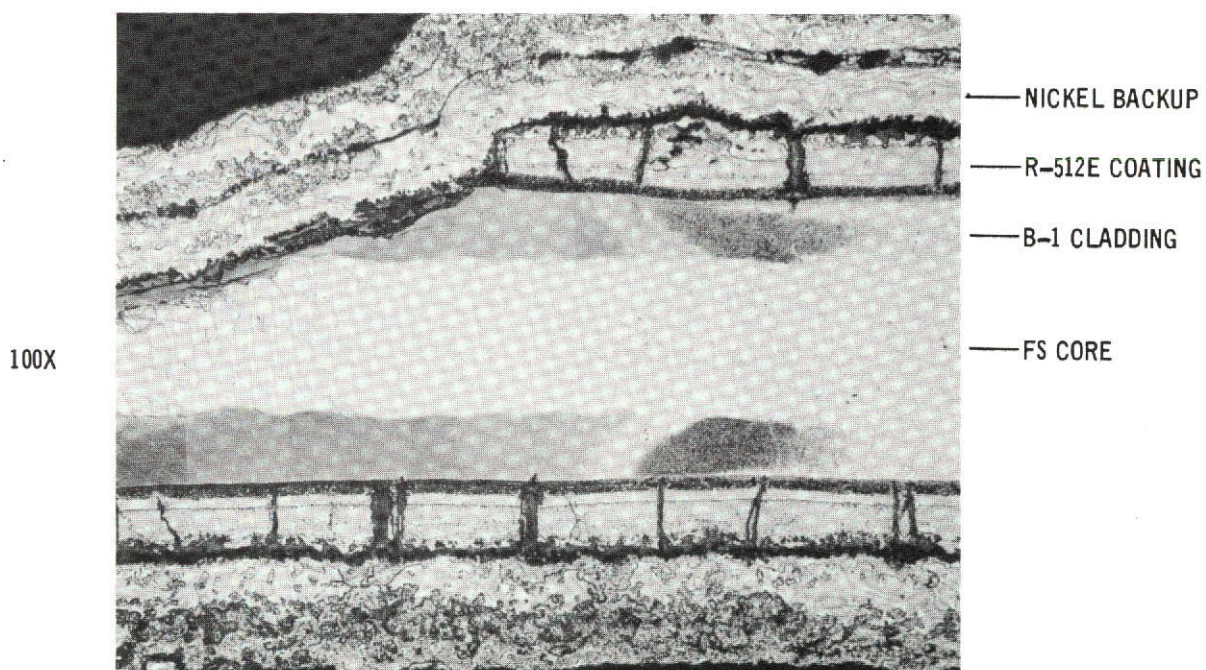
FIGURE 30 EFFECT OF 50 REENTRY PROFILE EXPOSURE CYCLES ON
NOMINAL 100 MICROMETER B-1 CLADDING

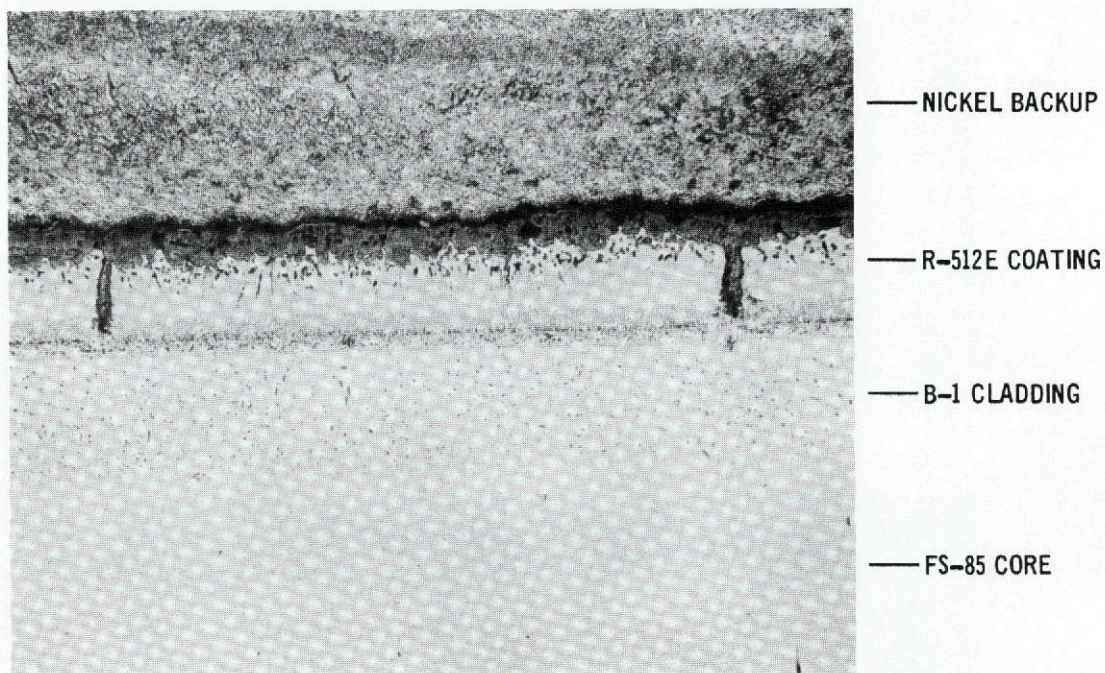
FIGURE 32 MICROSTRUCTURE OF NOMINAL 100 MICROMETER B-1 CLAD FS-85
AFTER 100 PROFILE REENTRY CYCLES

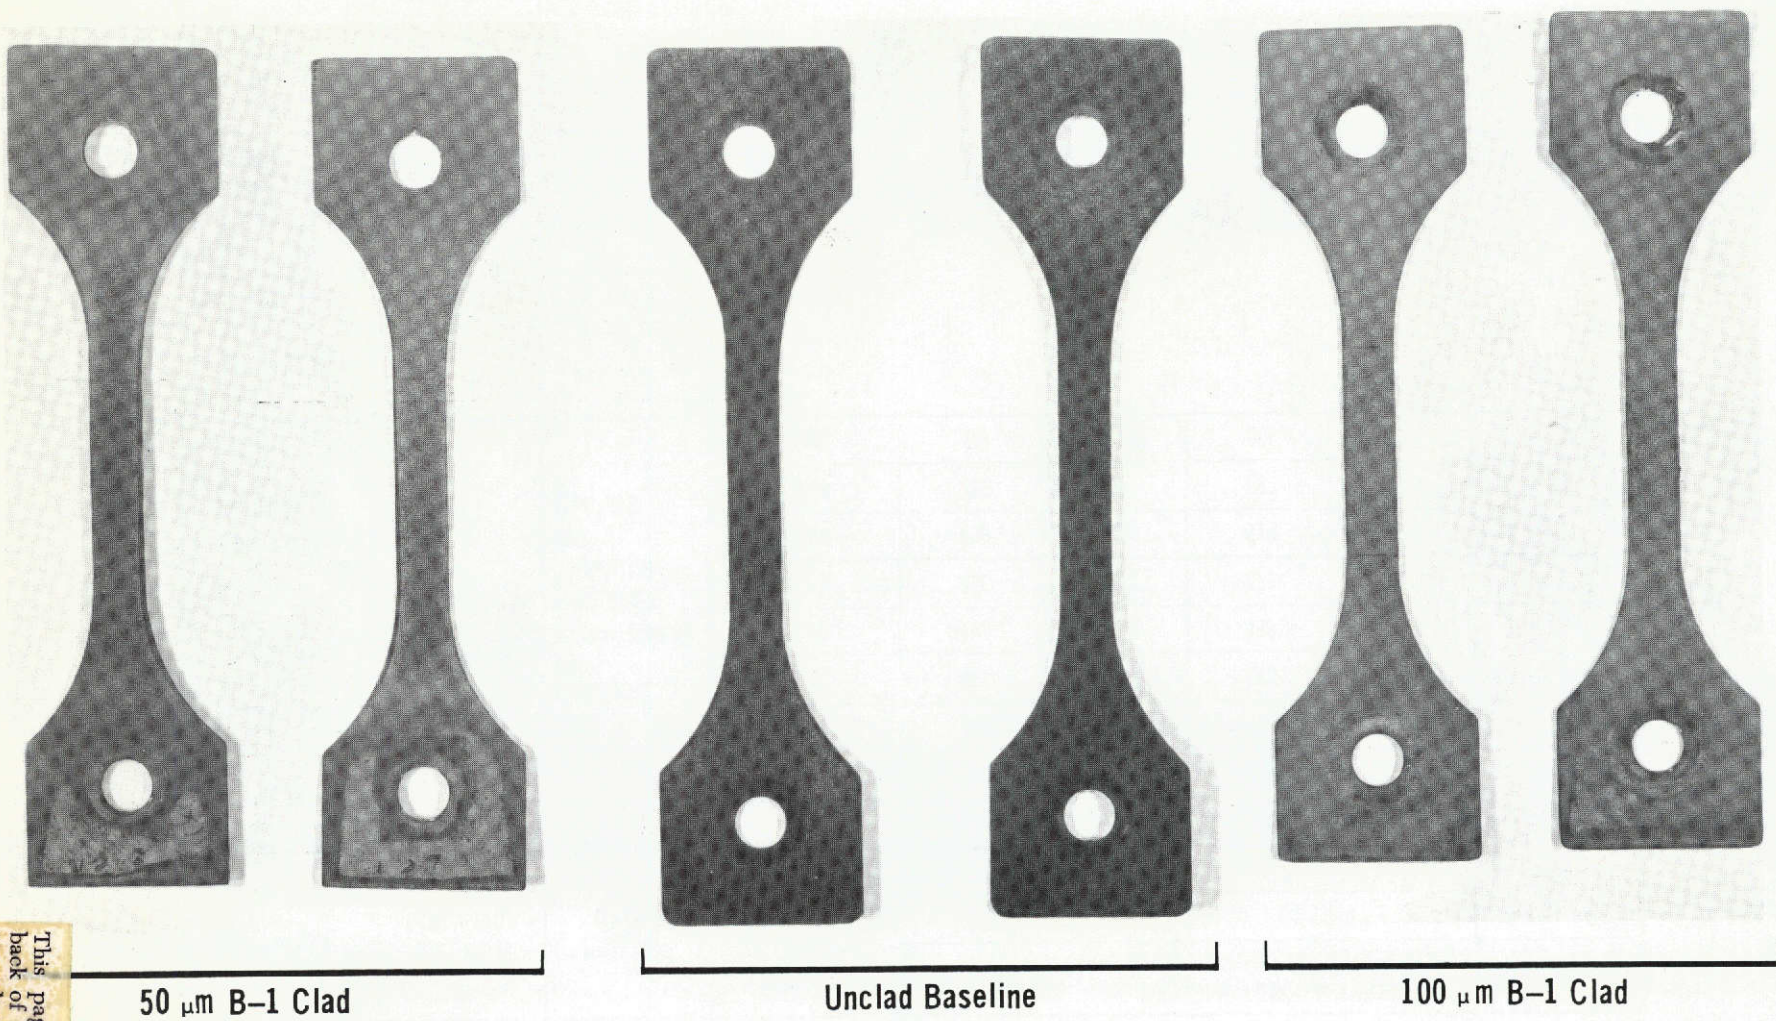
FIGURE 33 R-512E COATED CLAD AND UNCLAD FS-85 TENSILE SPECIMENS
AFTER 100 STRESS PROFILE CYCLES

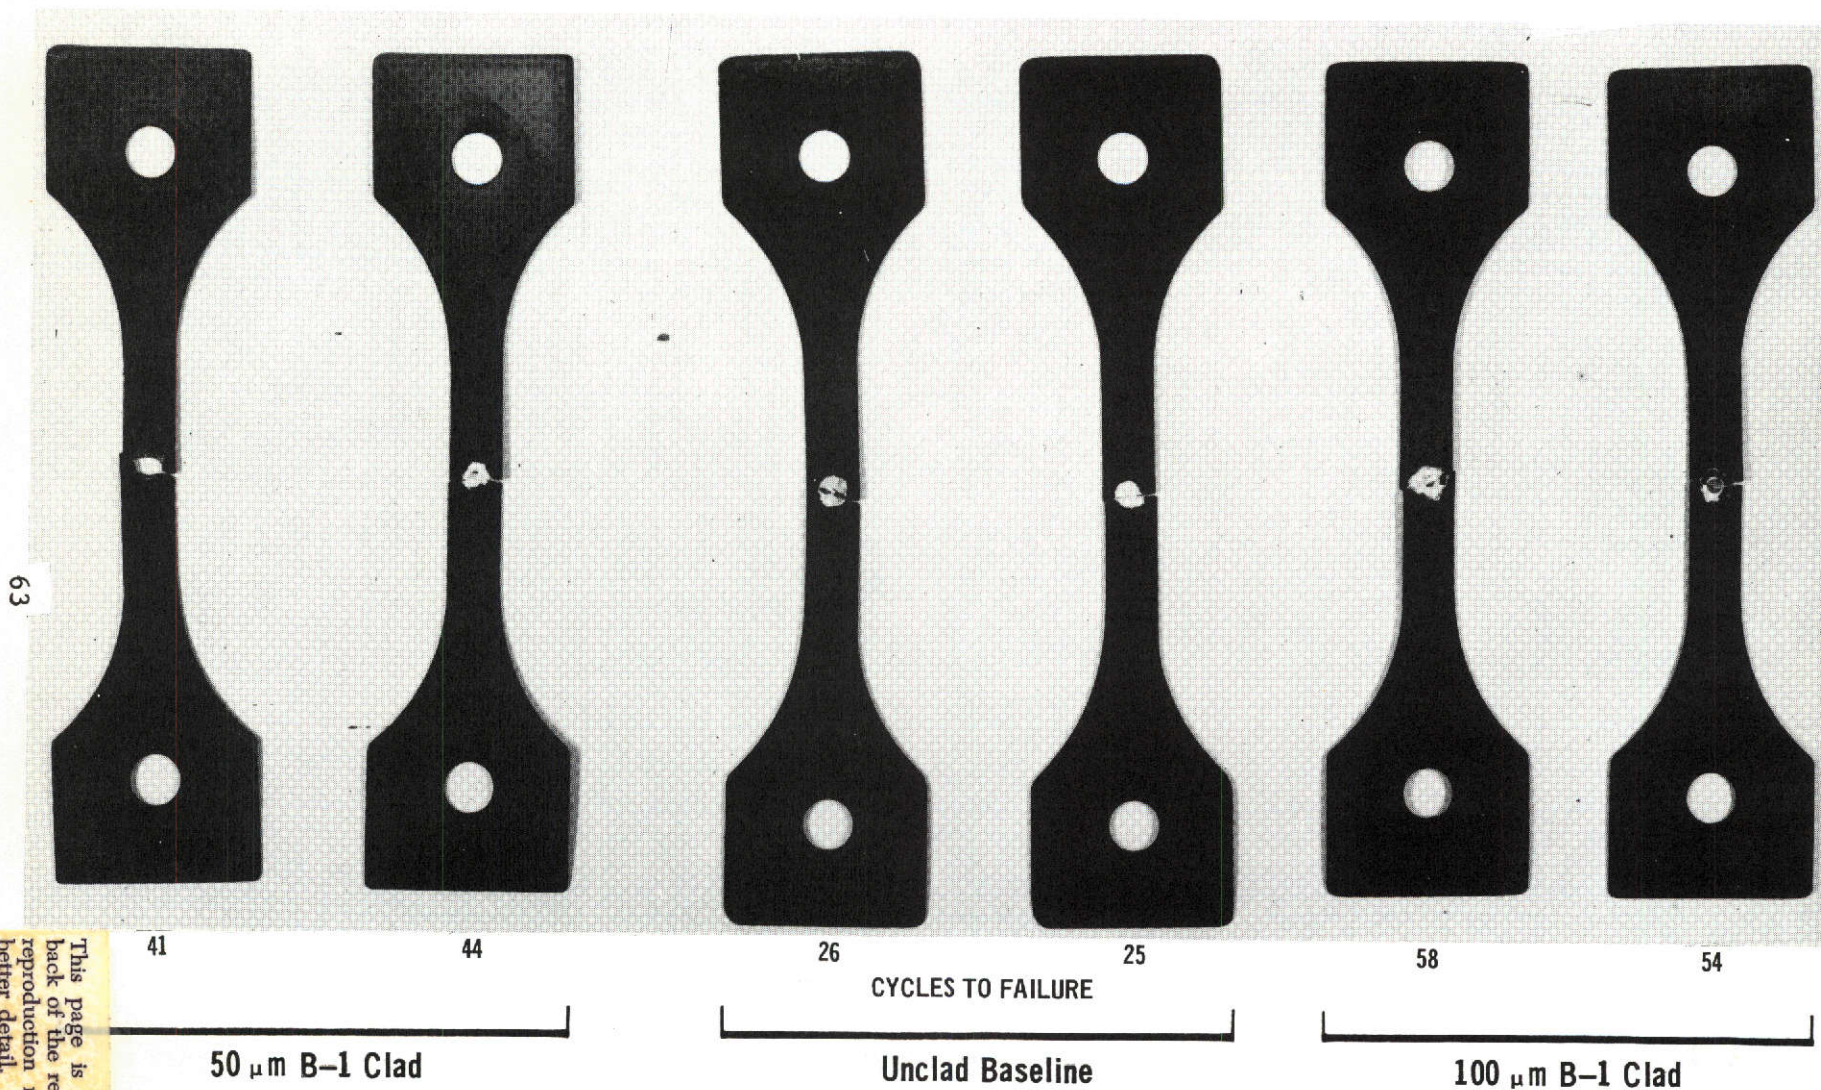
FIGURE 34 DEFECTED R-512E COATING ON CLAD AND UNCLAD FS-85 TENSILE SPECIMENS AFTER FAILURE DURING STRESS PROFILE CYCLING

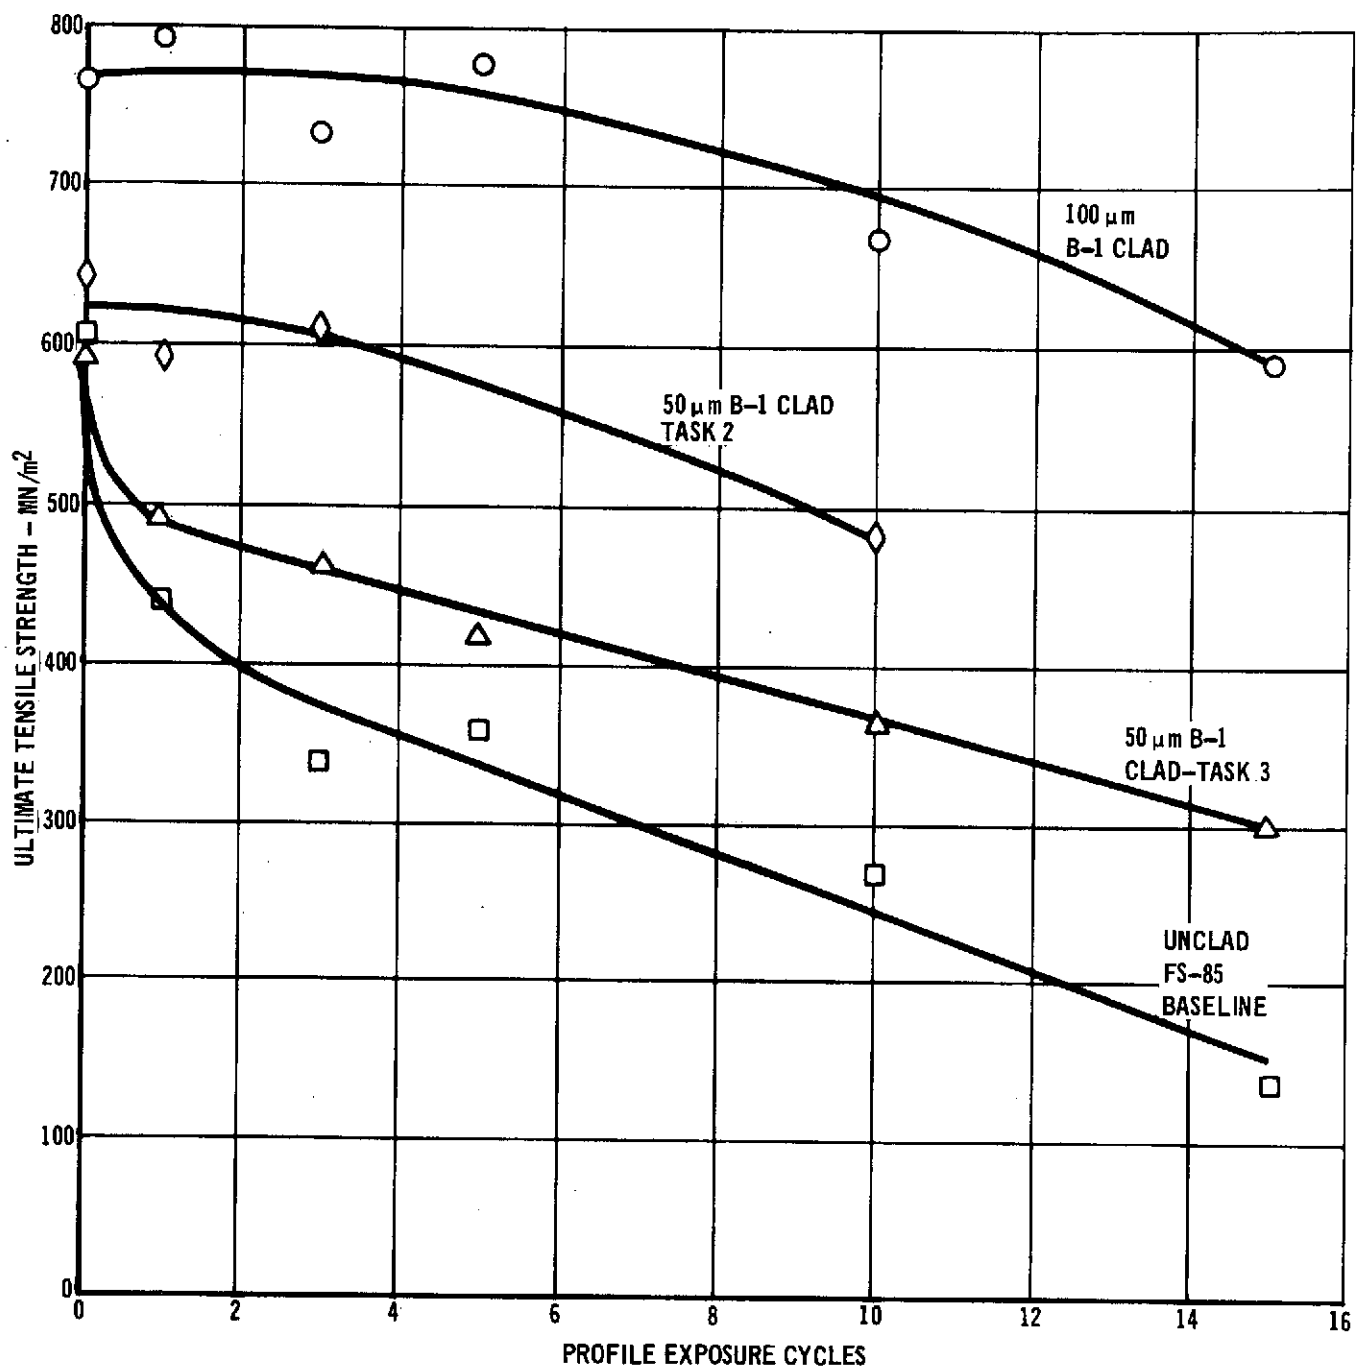
FIGURE 35. ROOM TEMPERATURE ULTIMATE TENSILE STRENGTH OF DEFECTED SPECIMENS AFTER VARIOUS REENTRY PROFILE EXPOSURES

The B-1 cladding of nominal 50 micrometer thickness was tested during two tasks and yielded somewhat different results. The results achieved in the second task were similar to the results described above with the nominal 100 micrometer cladding. That is, the cladding provided retention of the tensile properties (within approximately 8 percent) through three reentry profile cycles, with the ultimate tensile strength decreasing slightly and the yield strength increasing. In the experiment conducted in the final task using nominal 50 micrometer B-1 cladding, there was a 16 percent decrease in ultimate strength and a slight (7 percent) decrease in yield strength. While the clad material represented a significant improvement over the performance of the unclad FS-85, the improvement was in magnitude and not in character as had been observed previously. This qualitative difference in performance is shown in figure 35. The two upper curves represent the 100 micrometer B-1 cladding and the 50 micrometer cladding results of task 2. The cladding provides property

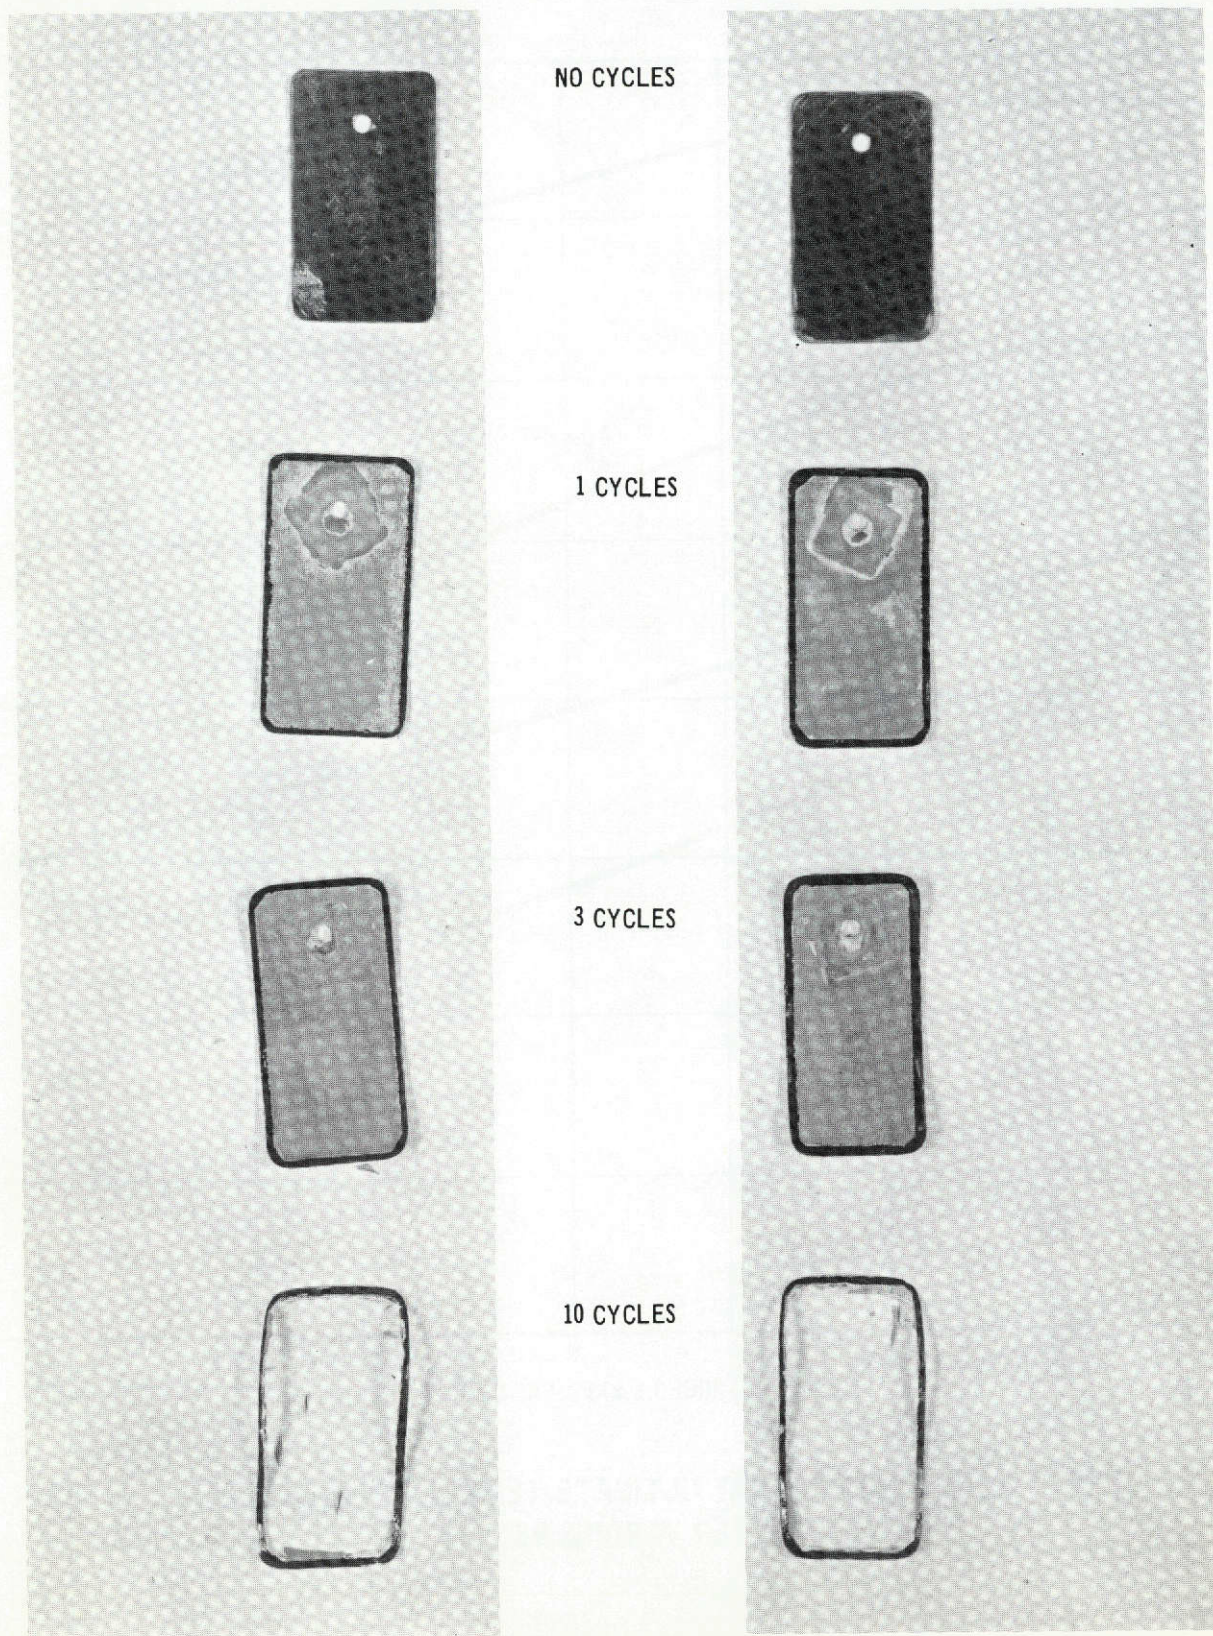
FIGURE 36 CLAD COUPONS WITHOUT R-512E COATED AFTER VARIOUS REENTRY PROFILE EXPOSURE CYCLES

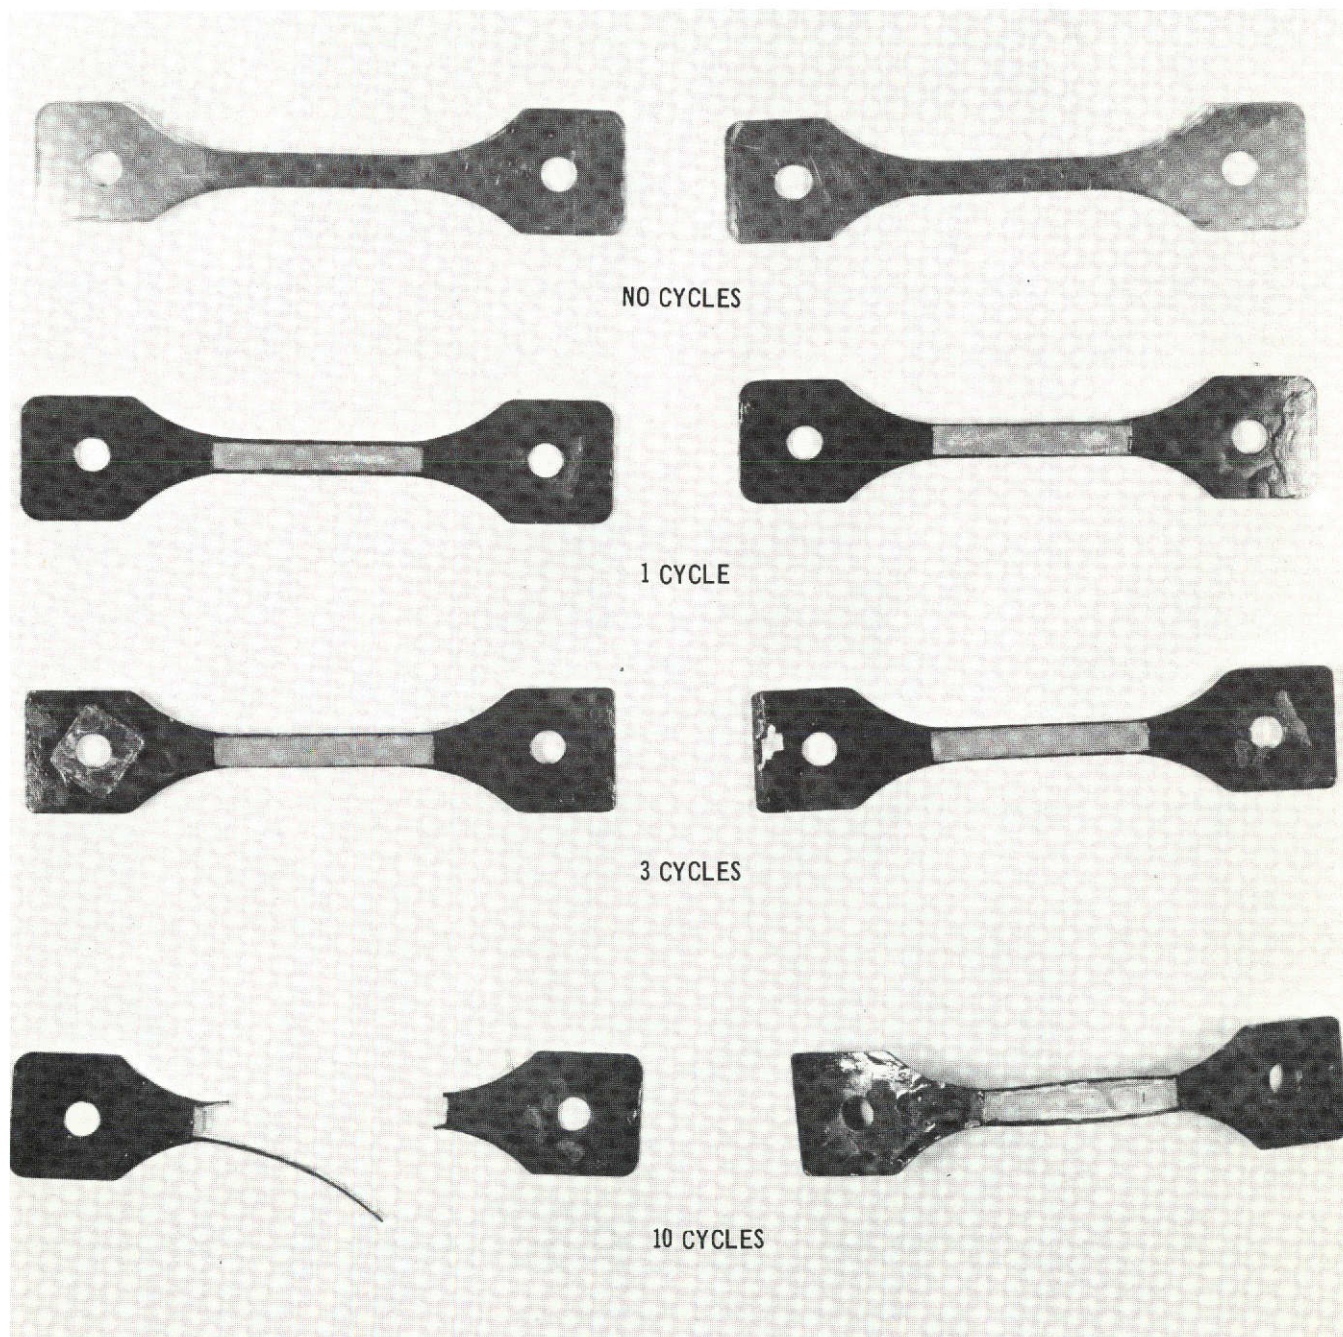
FIGURE 37 B-1 CLAD TENSILE SPECIMENS WITHOUT R-512E COATING AFTER VARIOUS REENTRY PROFILE EXPOSURE CYCLES

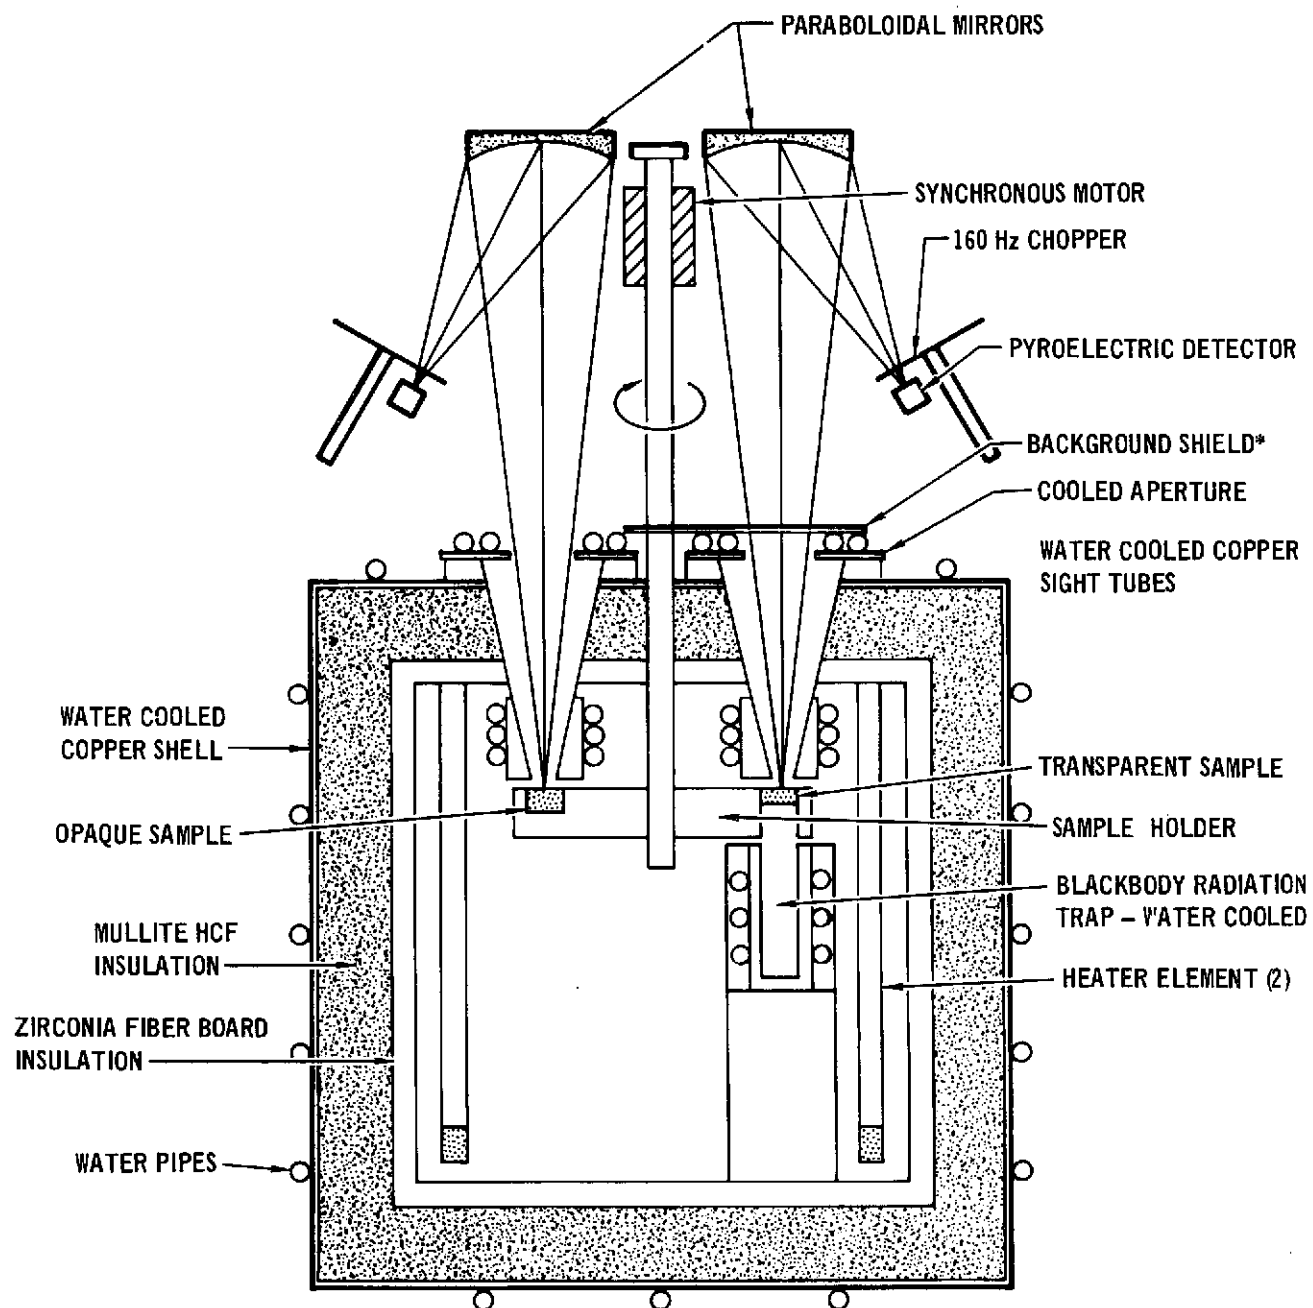
*SHOWN OUT OF POSITION IT DOES NOT INTERSECT BEAM WHEN SAMPLE IS UNDER SIGHT TUBE.

FIGURE 41 DIAGRAM OF ROTATING SAMPLE EMISSOMETER

The optical transfer system consisted of a sight tube, several apertures, the background shield, a mirror, and a 160 Hz chopper. The 7.6 cm diameter by 152 cm focal length paraboloidal mirror formed a reduced image of the end of the sight tube on the pyroelectric detector. An

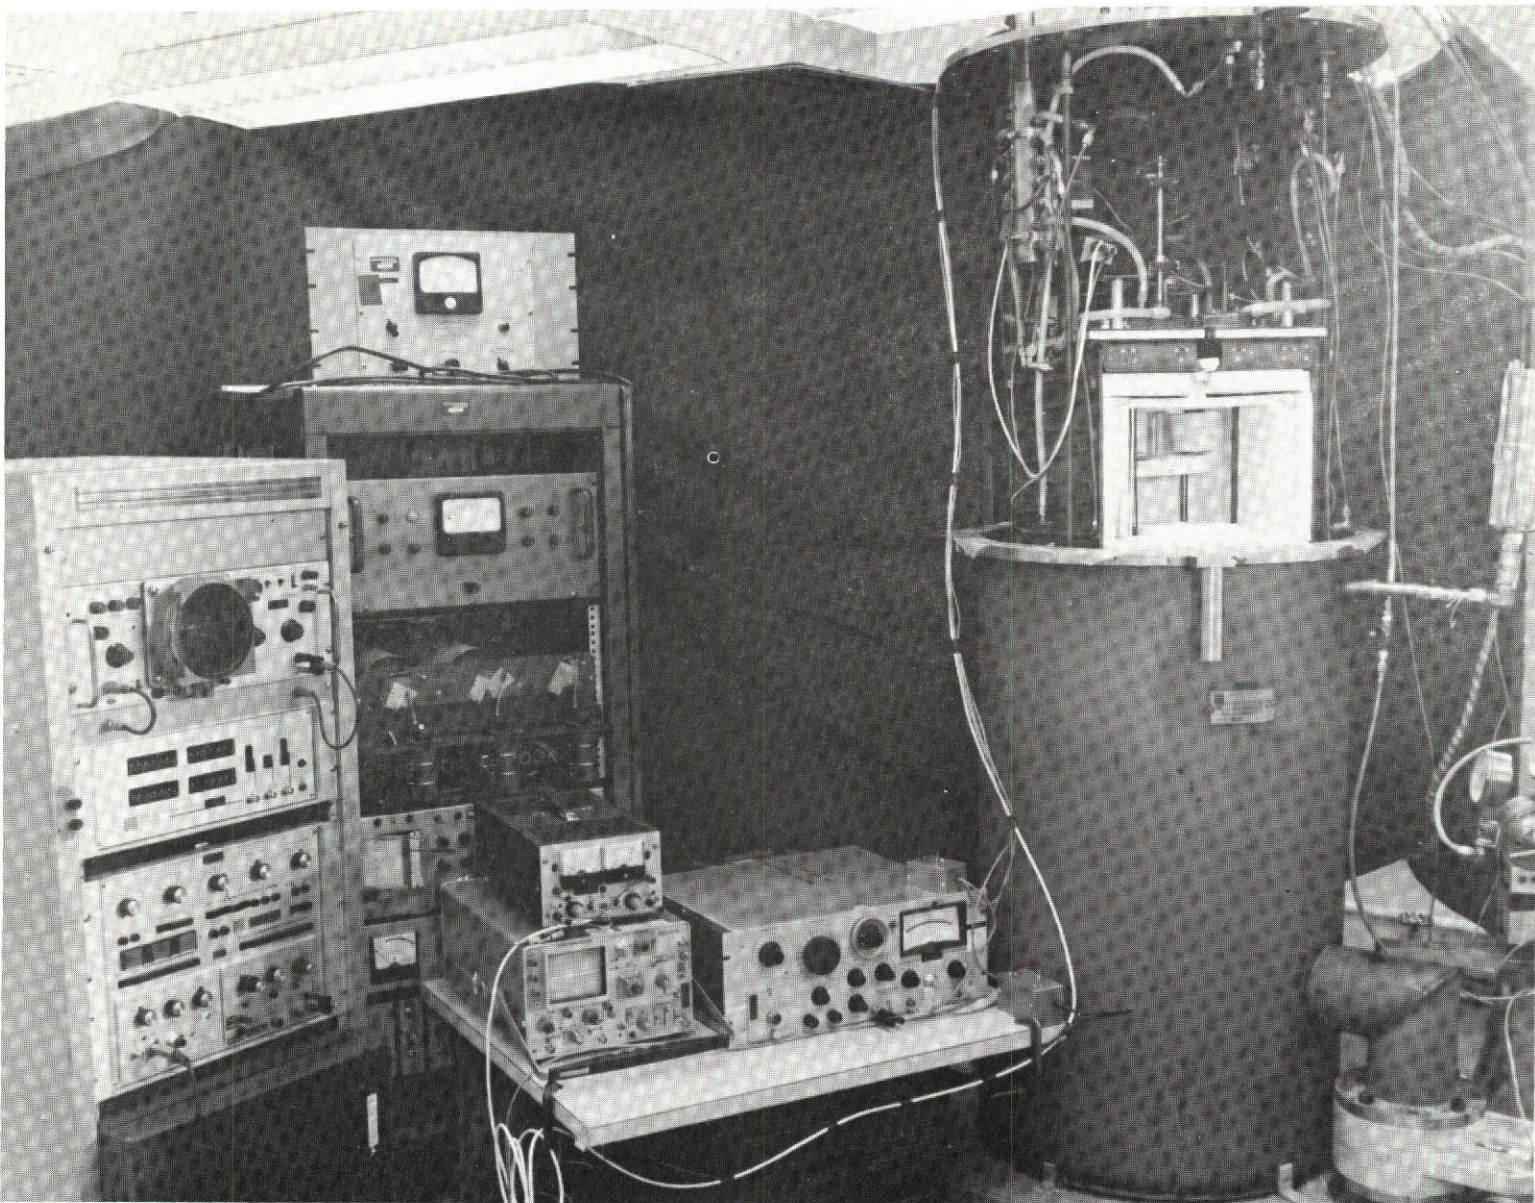
FIGURE 42 ROTATING SAMPLE EMISSOMETER

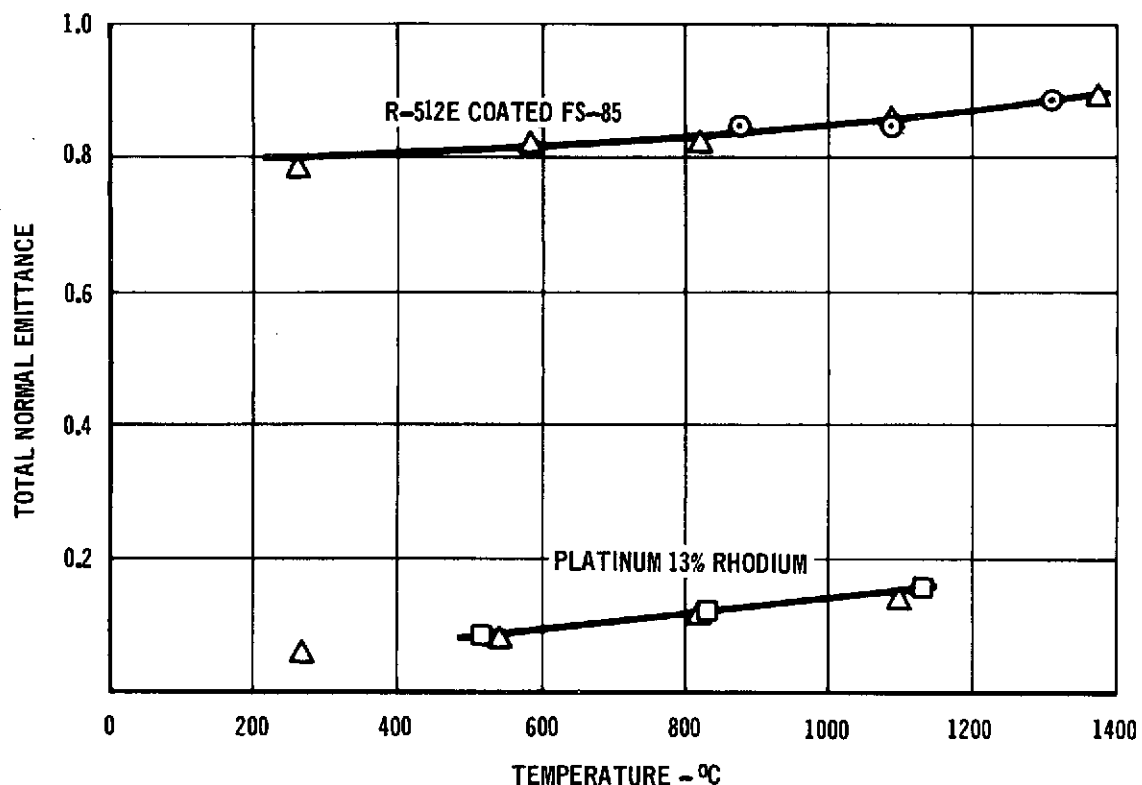
- △ ROTATING SAMPLE EMISSOMETER DATA FOR RESPECTIVE SAMPLES
- DATA GENERATED ON CONTRACT NAS3-14307- EMITTANCE SPEC. 13
- NBS DATA (USAF-WADC-TR 59-510 PT IV)

FIGURE 43 CHECK OUT RESULTS FOR ROTATING SAMPLE EMISSOMETER

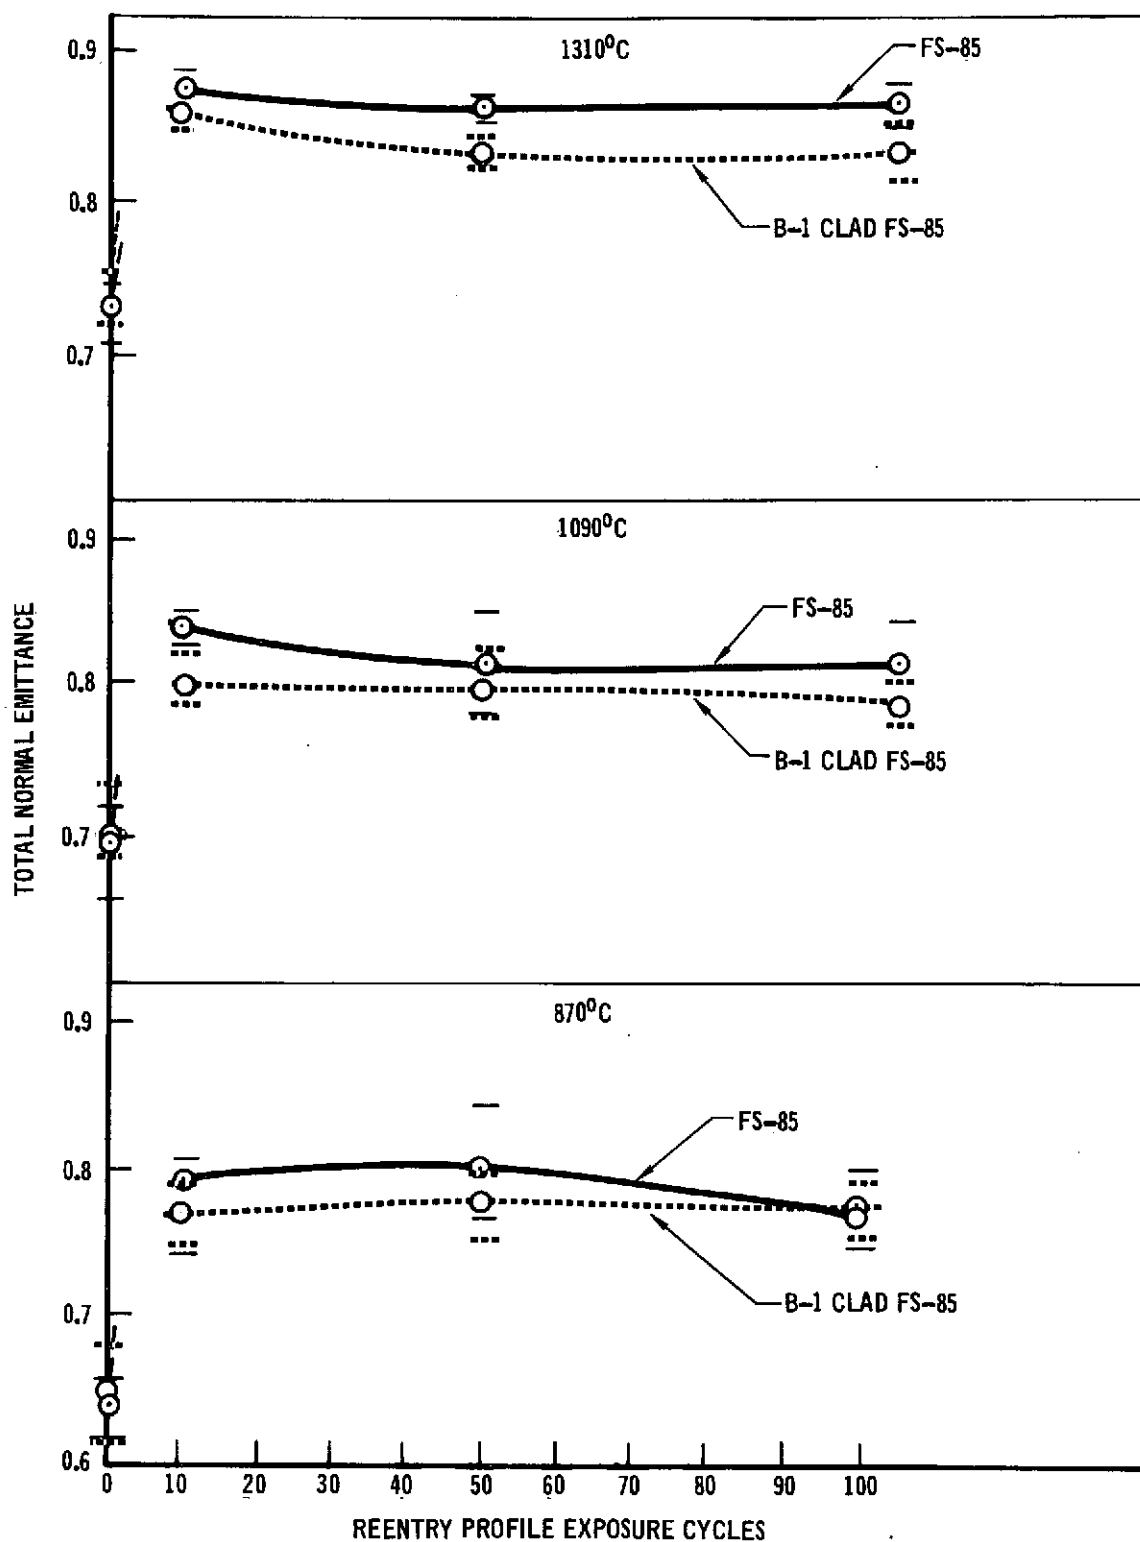
FIGURE 44 EMITTANCE OF R-512E COATED B-1 CLADDING AND FS-85

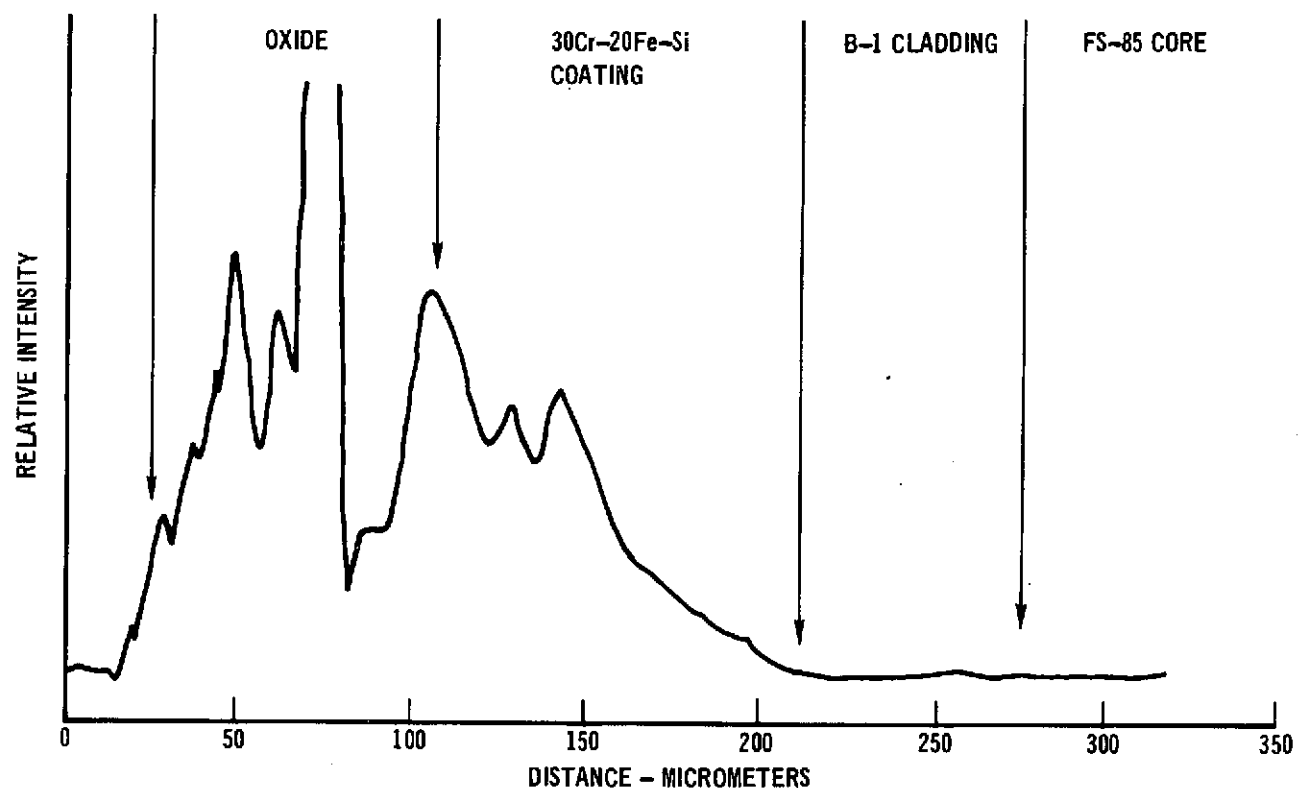
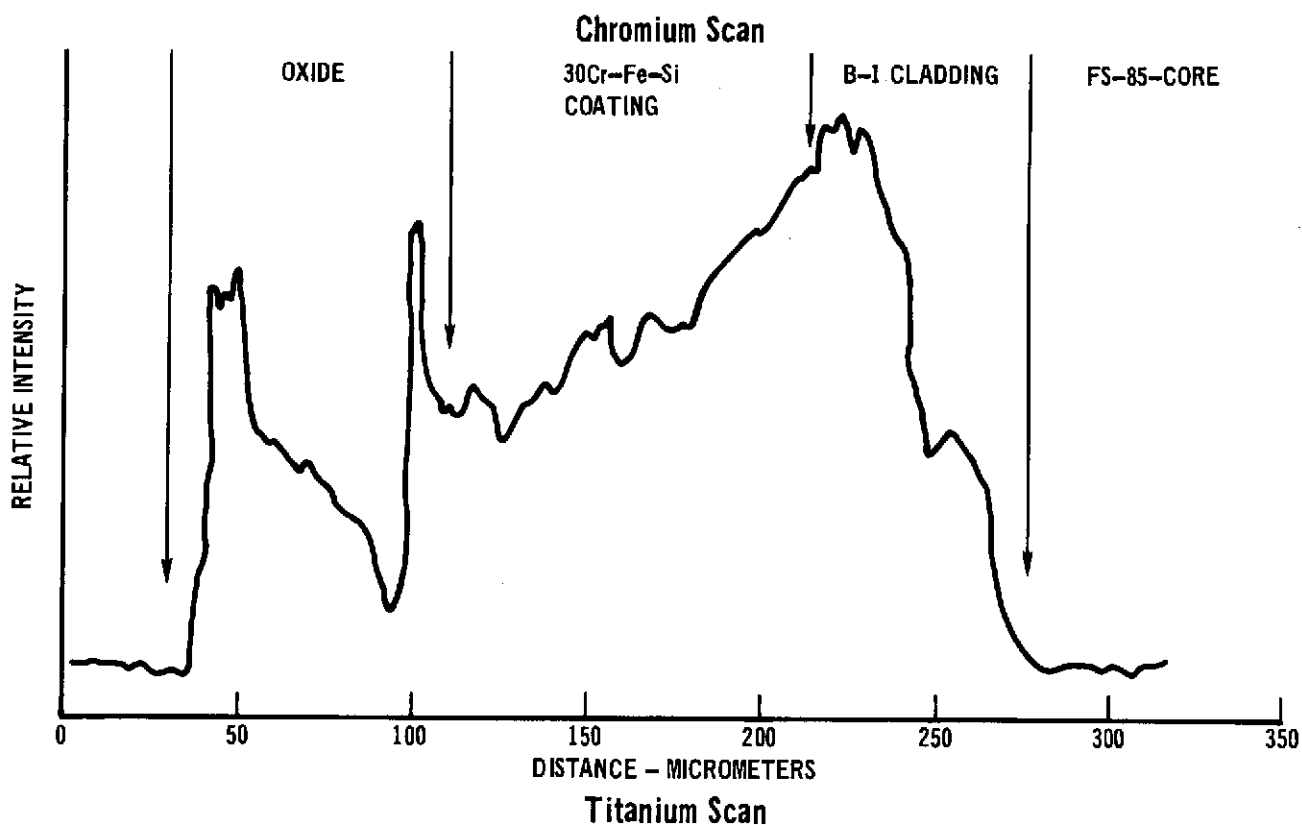
FIGURE 46 ELECTRON MICROPROBE SCANS OF B-1 CLAD FS-85 WITH 30Cr-20Fe-Si COATING AFTER 100 REENTRY PROFILE CYCLES (TASK I EXPERIMENT)

Qualitative electron microprobe scans were made on typical 100 profile exposure cycle specimens for the first two program tasks. The results achieved are presented in figures 45 through 49. The most significant findings were the presence of a sharp interface between the B-1 cladding and the substrate and the absence of cladding alloy constituents migrating into the FS-85 core. This was a positive indication that titanium or aluminum was not diffusing into the FS-85 core to impair the mechanical properties (particularly creep strength) after long exposure times. The remaining scans indicated that the coatings were acting in a normal and predictable way, since the results obtained were similar to those found by HiTemCo, (reference 8).
